# CCTV REPORT

<b>CLIENT</b>	CATTON HOMES
<b>LOCATION</b>	BATFORD MILL LOWER LUTON ROAD HARPENDEN AL5 5BZ
<b>DATE</b>	29/09/2020
<b>REF</b>	071319-02
<b>DVD No</b>	002

**071319 02 BATFORD MILL LOWER LUTON ROAD HARPENDEN - CCTV Survey  
Report : 29/09/20**

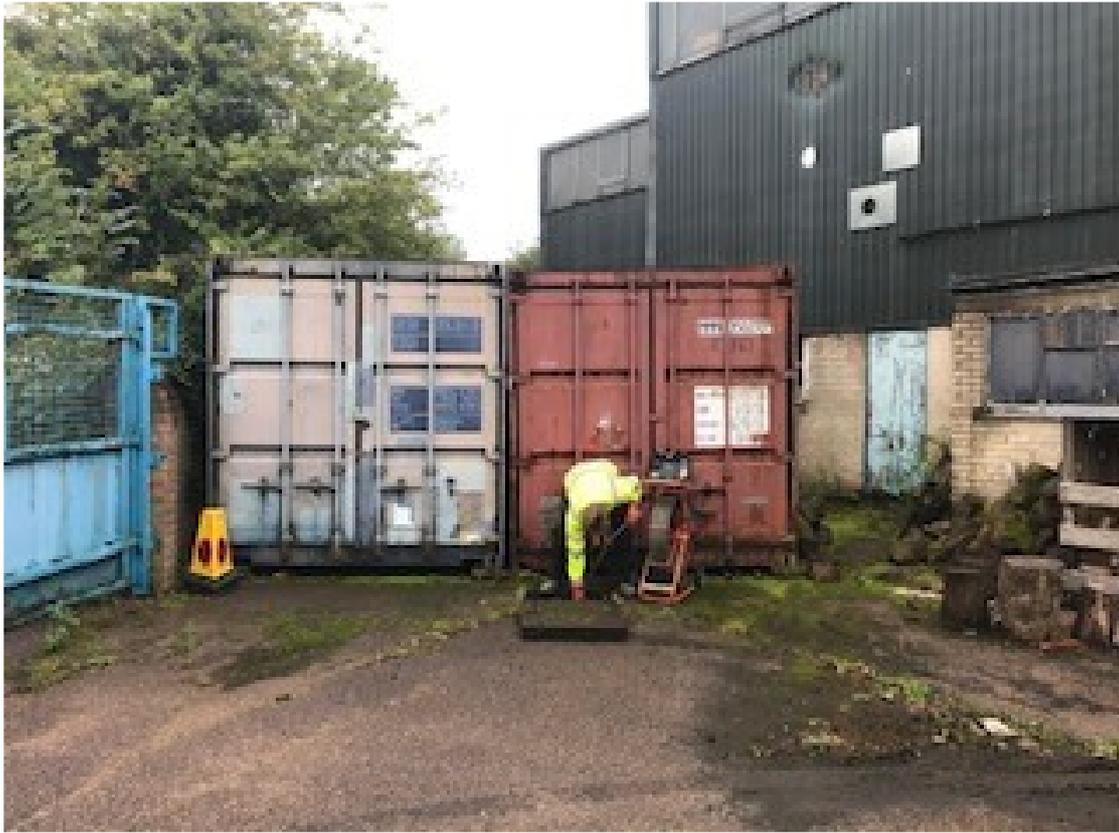
MH S1

<p>MH No. S1 DEPTH. 0.80 COVER. SH CONSTRUCTION. Br REMARKS. CATHPIT</p>

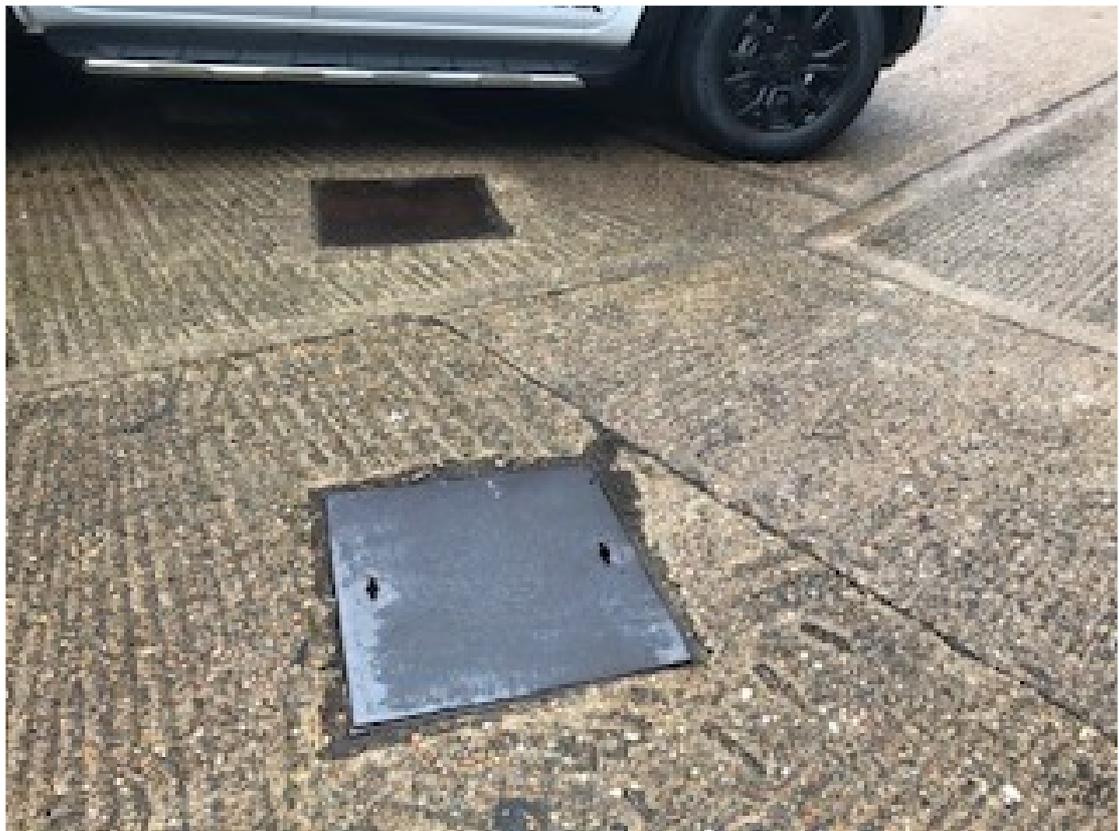
MH S2 (2 CHAMBER INTERCEPTOR)

<p>MH No. S2 DEPTH. 1.75 COVER. SM CONSTRUCTION. Co REMARKS. 2 CHAMBER INTERCEPTOR</p>

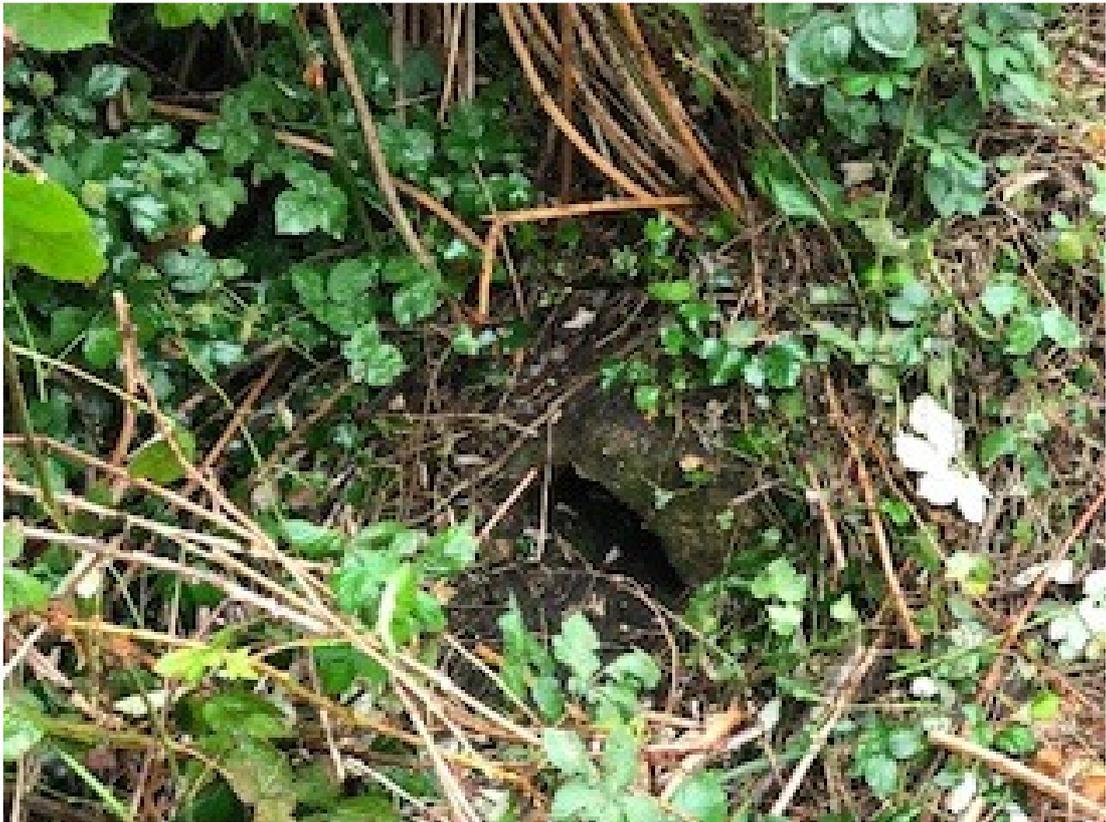
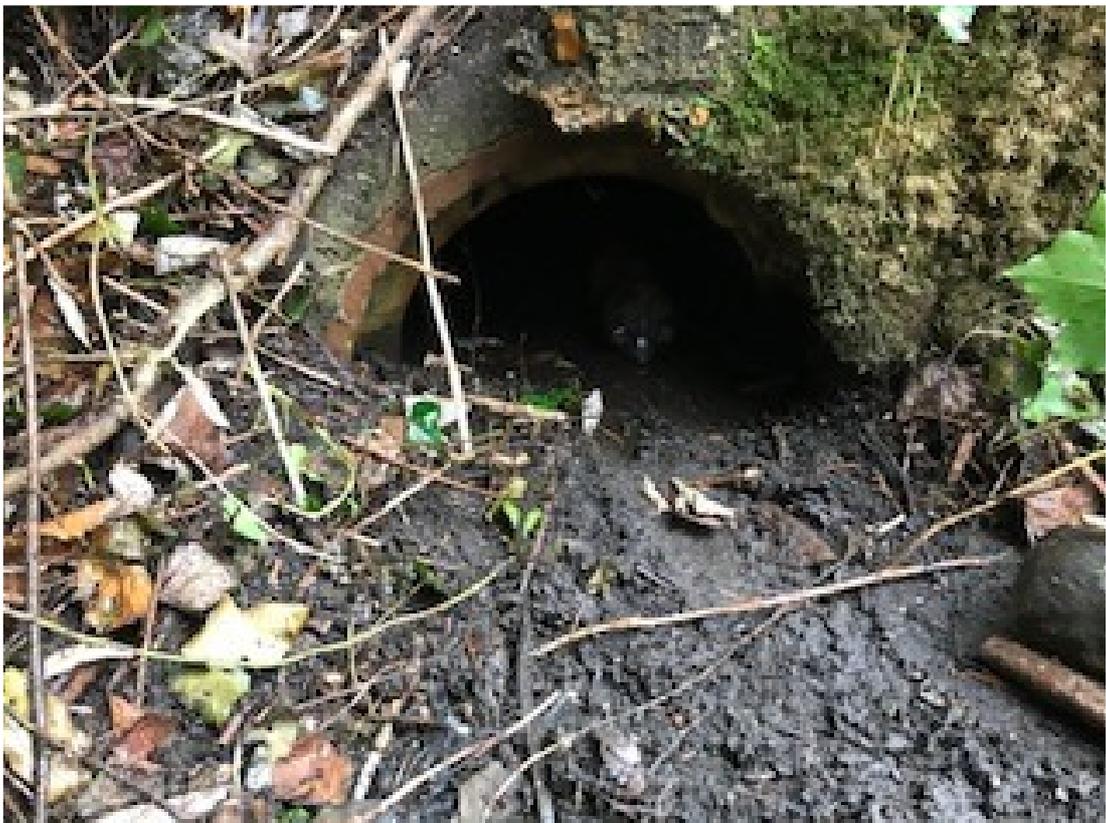
OUTFALL 02

Remarks OUTFALL 2 - S2 60% SILT & MUD  
S2 - OUTFALL 2 NO ACCESS FOR CAMERA

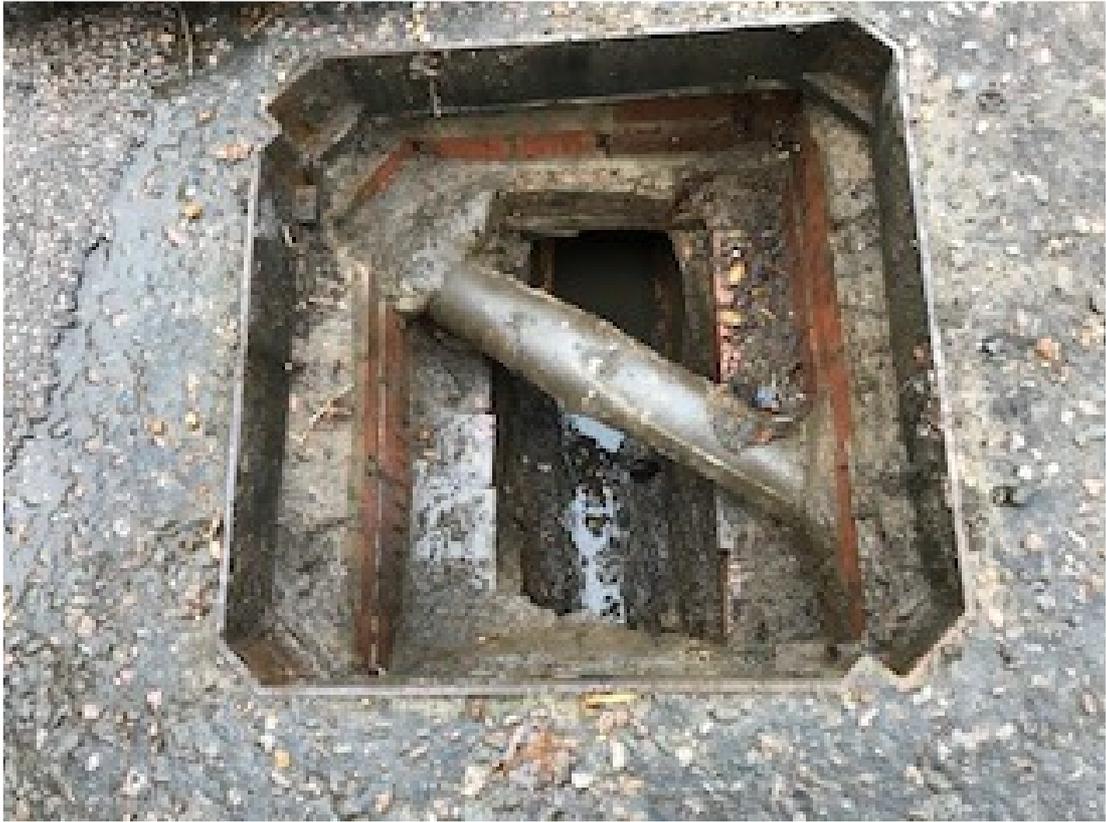
MH S4

<p>MH No. S4 DEPTH. 0.60 COVER. SH CONSTRUCTION. Br REMARKS. SERVICES RUNNING THROUGH MANHOLE</p>
