**Updated Phase I and II
Contamination
Investigation & Risk
Assessment Report**

Project Name: Harpenden Lane, Redbourn

Project ID: JN1847

Report Date: 11 December 2025

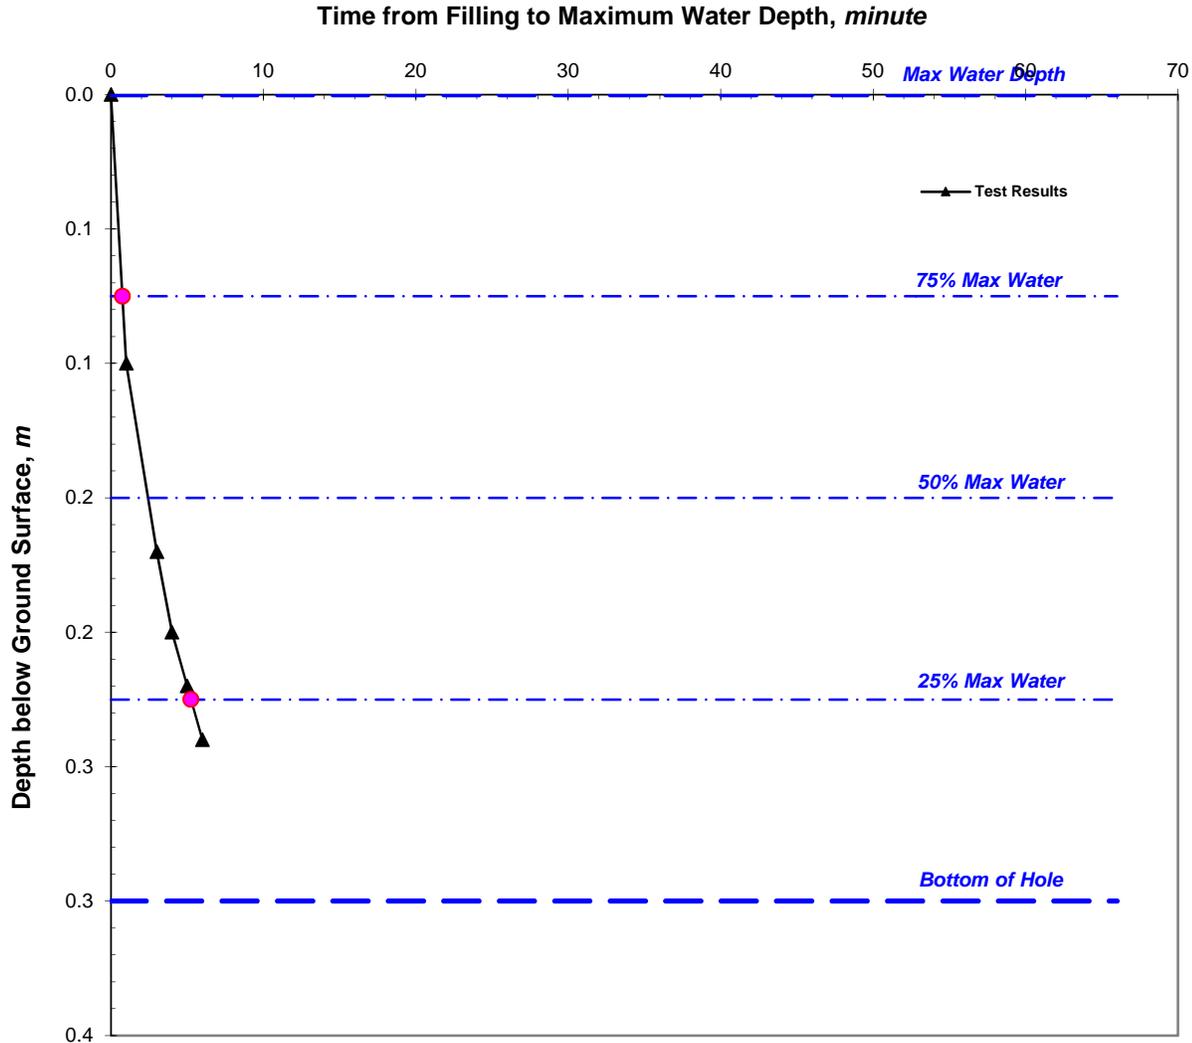
Test Hole No: 2
 Test No: Test No 1 (Initial)

Pit Length, m	1.100	Depth to Water at Start of Test, m	0.000
Pit Width, m	0.450	Max Water Dropdown during Test, m	0.240
Depth to Pit Base, m	0.300	Total Soakage Test Time, min	66.0
Depth to Top of Permeable Soils, m	0.200	Mean Internal Discharge Area, m ²	0.799
Depth to Groundwater Surface, m	0.300	Discharge Rate, litre/min	0.460
Depth to Top of Granular Fill, m	0.000	Soakage Rate, litre/m ² /min	0.577
Voids Assumed for Granular Fill, %	40%	BRE Soil Infiltration Rate, m/sec	9.61E-06

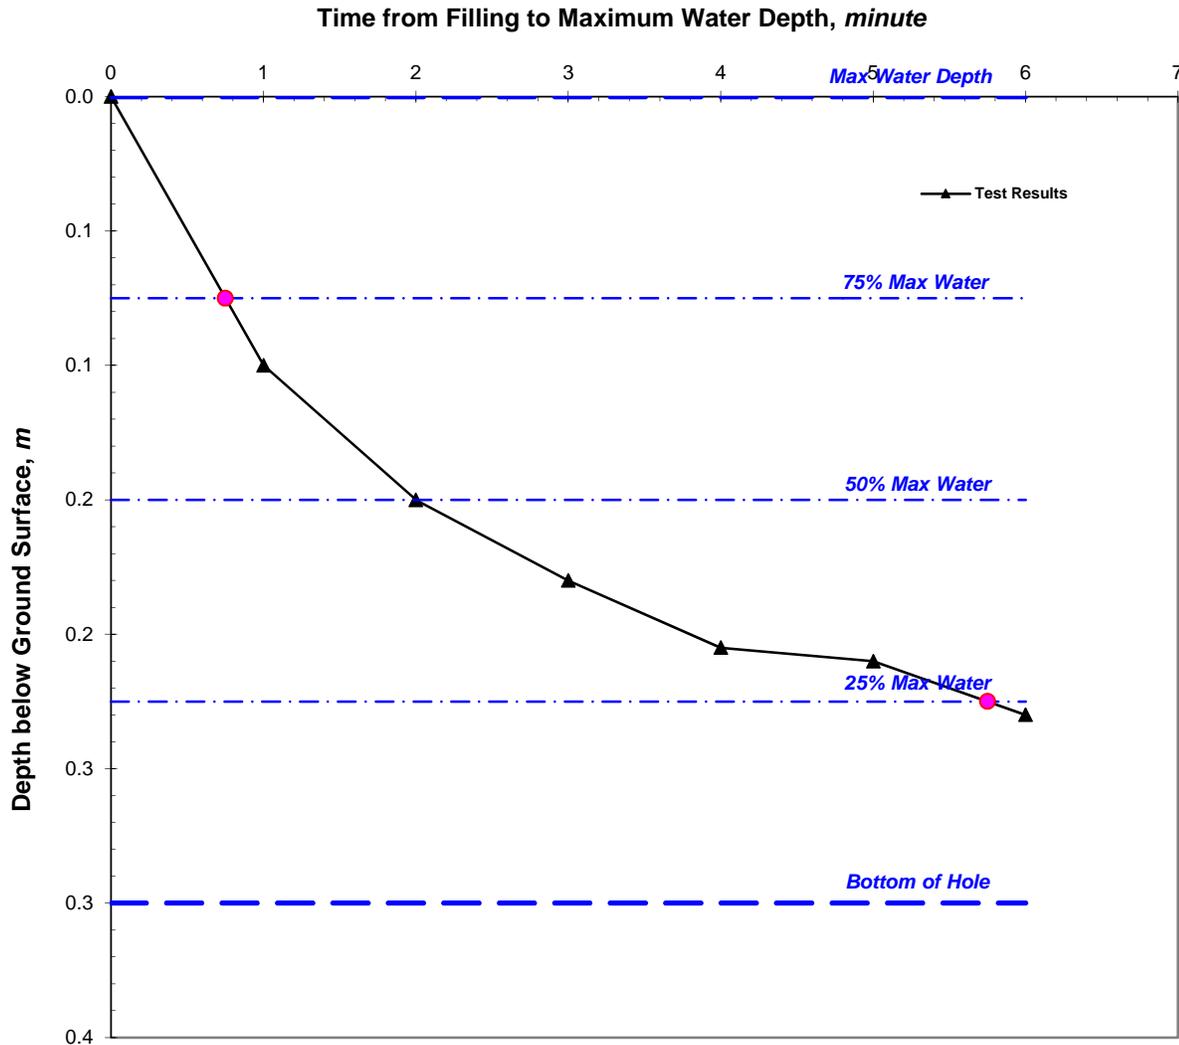
Test Hole No: 2
 Test No: Test No 2 (Repeated)

Pit Length, m	1.100	Depth to Water at Start of Test, m	0.000
Pit Width, m	0.450	Max Water Dropdown during Test, m	0.230
Depth to Pit Base, m	0.300	Total Soakage Test Time, min	6.0
Depth to Top of Permeable Soils, m	0.200	Mean Internal Discharge Area, m ²	0.799
Depth to Groundwater Surface, m	0.300	Discharge Rate, litre/min	5.940
Depth to Top of Granular Fill, m	0.000	Soakage Rate, litre/m ² /min	7.44
Voids Assumed for Granular Fill, %	40%	BRE Soil Infiltration Rate, m/sec	1.24E-04

Comments:
Pit was nearly emptied at finish of test.
