**Updated Phase I and II
Contamination
Investigation & Risk
Assessment Report**

Project Name: Harpenden Lane, Redbourn

Project ID: JN1847

Report Date: 11 December 2025

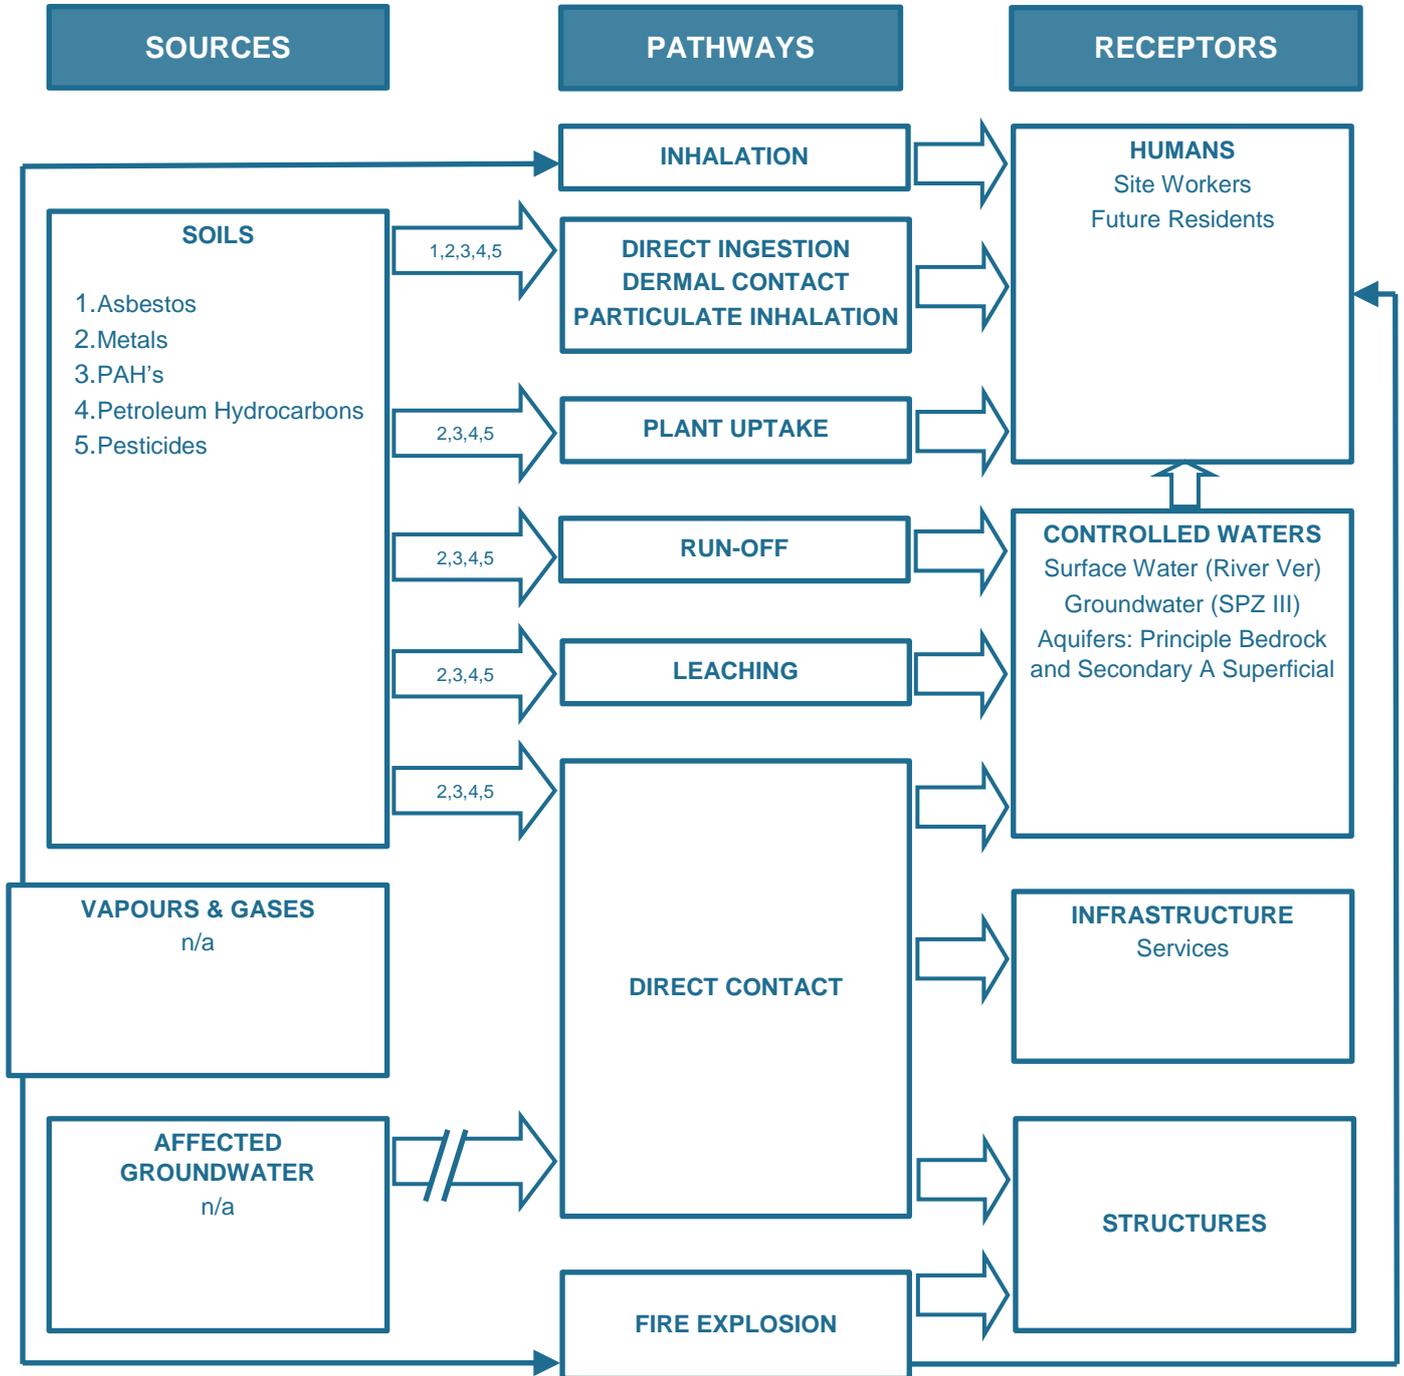
The following diagram shows the potential pollutant linkages identified for the site and summarises the preliminary conceptual model:

// Denotes potential pollutant linkage not complete.
